CITY OF NEW RICHMOND, WI

NEW RICHMOND  
COMMONS, LIBRARY & CITY HALL  
PRE-DEVELOPMENT CHARETTE

PHASE II – FEASIBILITY OF BUILDING  
RENOVATION / DEMOLITION / EXPANSION

FINAL REPORT

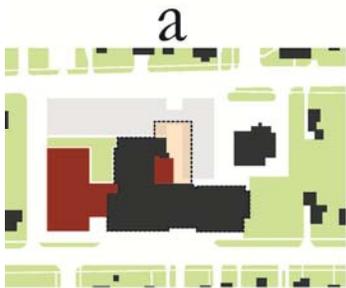
Pros

- Co-locates partners
- City campus
- Keeps old school, gym
- Possibility of City Hall
- Potential shared atrium

Cons

- Potential cost
- Unknowns re/ existing
- Financial standing
- Code, upkeep backlog

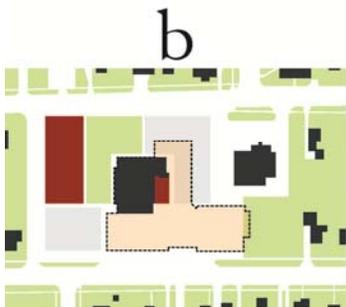
- Keeps old school
- Room for new

- Loss of gym amenity
- Cost of building new
- Not enough space
- Doesn't leverage enough of the existing

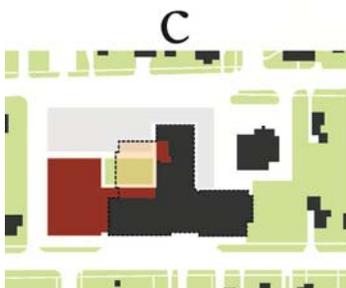
Pros

- Co-locates partners
- Potential shared atrium

Cons

- Loss of historic building
- Code, upkeep backlog
- Revenue imbalance

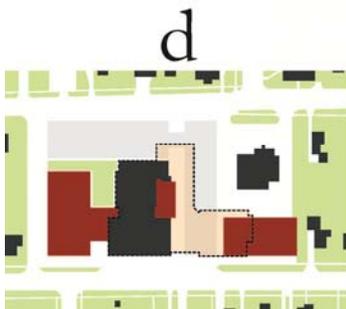
- Keeps old school, gym
- Partners or City Hall
- Potential shared atrium
- Financial standing

- Potential cost
- Less space for Commons Partners
